TT 1933-S

Multi-touch Operating Panel

The TT 1933-S is an intelligent terminal for programming and visualization of automated processes. Process diagnostics as well as operating and monitoring automated procedures are simplified using this terminal.

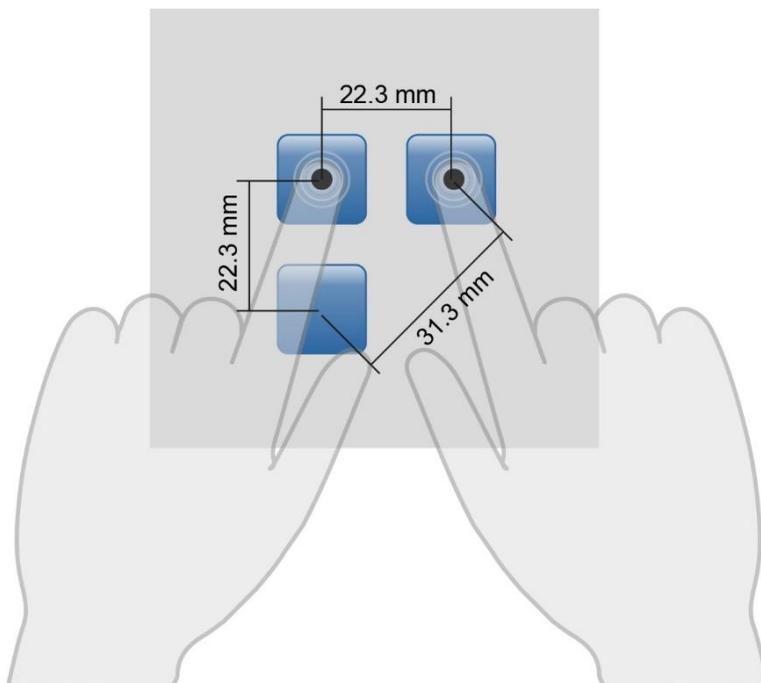
Distance needed for operating elements in multi-touch applications:

In order to guarantee smooth operation in multi-touch applications, buttons and control elements, which should be operated at the same time, must have the minimum distance shown below (depending on the estimated touch point).

The size of the buttons and operating elements directly affect the operability of the application. Small operating elements should therefore be avoided.

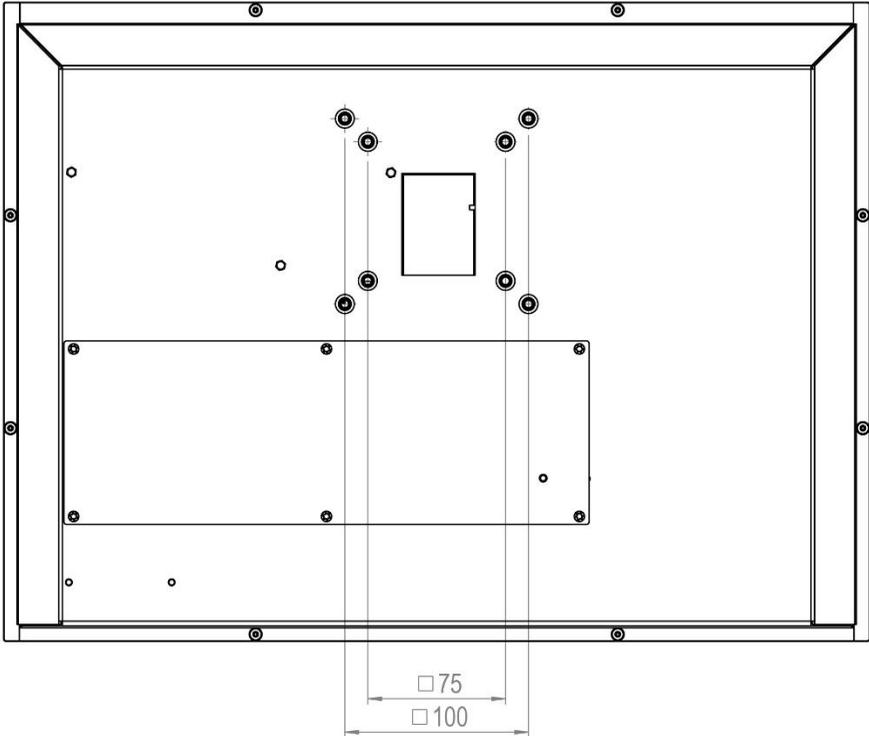
2.1 Carrier Arm Mount

- IP54 only with VESA100 carrier arm whose connection meets IP54.
- With VESA75, IP54 can only be achieved when the VESA100 mounting holes are covered or closed using screws.
- VESA75 & VESA100 with M5 threads
- Maximum screw depth 10 mm, based on the housing surface

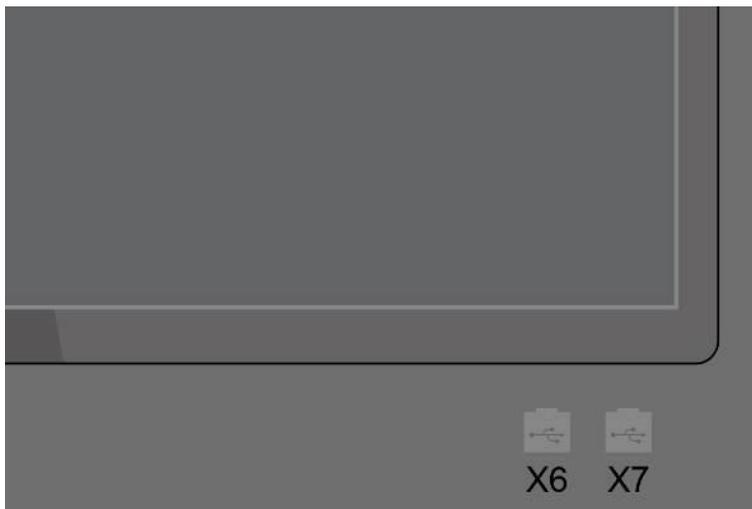
3.1 Front

X6, X7: USB Type A 2.0

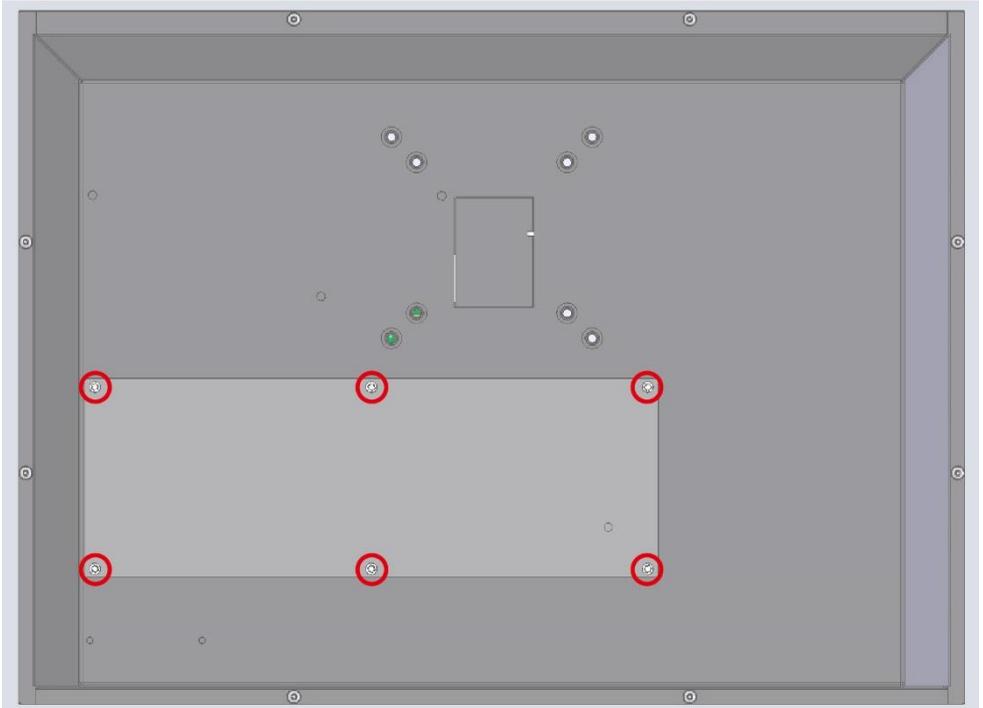
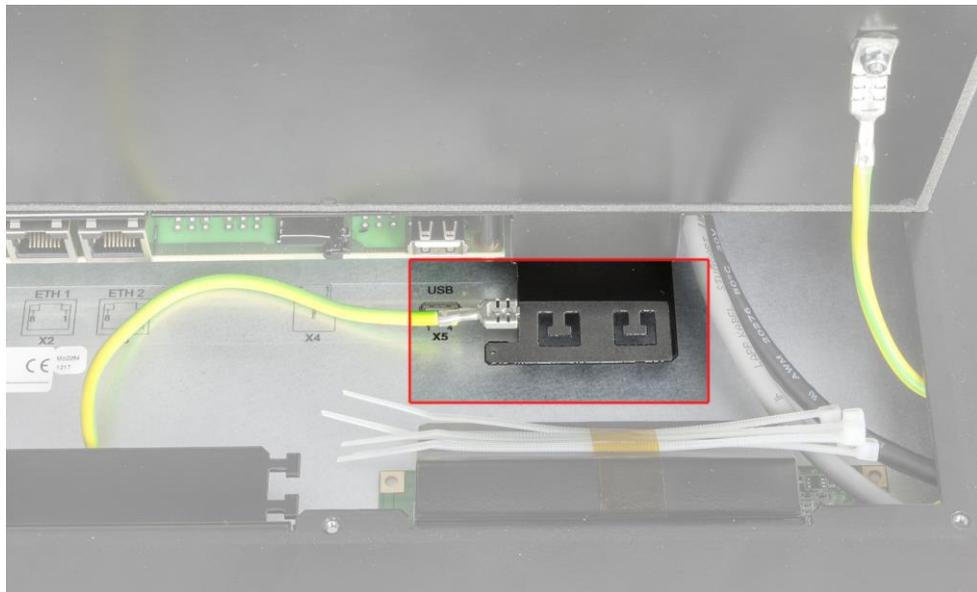
To access the interfaces, the inspection cover secured with six countersunk (TX10) screws, must first be removed. For this purpose, the six screws must be removed and the cover carefully lifted.

The cover is connected to the housing with the ground cable, which can be disconnected if necessary. The cable must however, be reconnected when replacing the cover.

The cable ties are for strain relief. Here, the shielding of the individual cables can be placed.

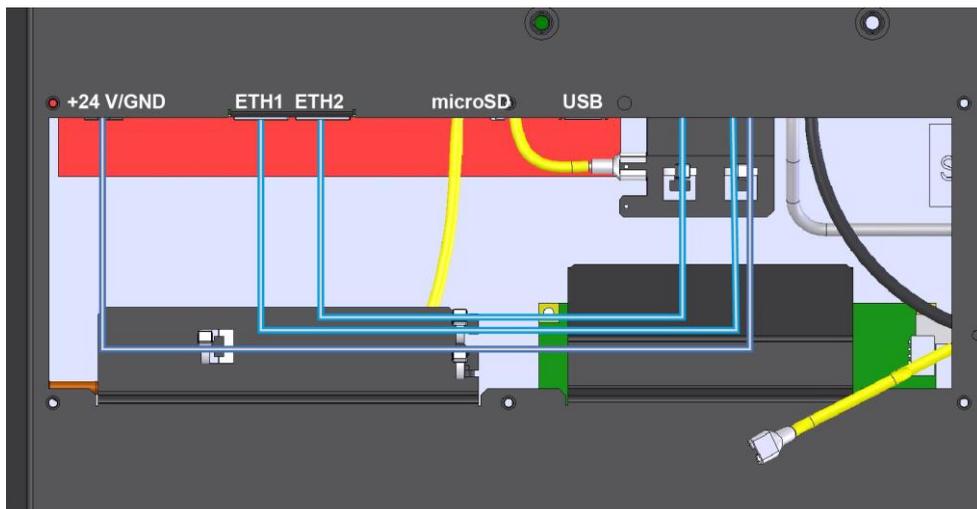
X1: Supply (3-pin Phoenix RM 3.5)

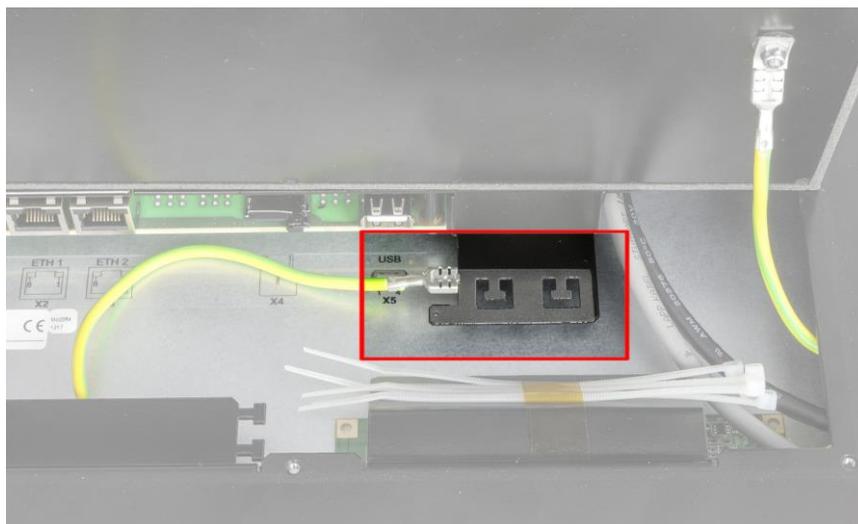
6.1 Ground

The terminal must be connected to ground through the assembly on the control cabinet/carrier arm or over the connection provided. It is important to create a low-ohm ground connection, only then can error-free operation be guaranteed. The ground connection should have a maximum cross section and the largest (electrical) surface possible.

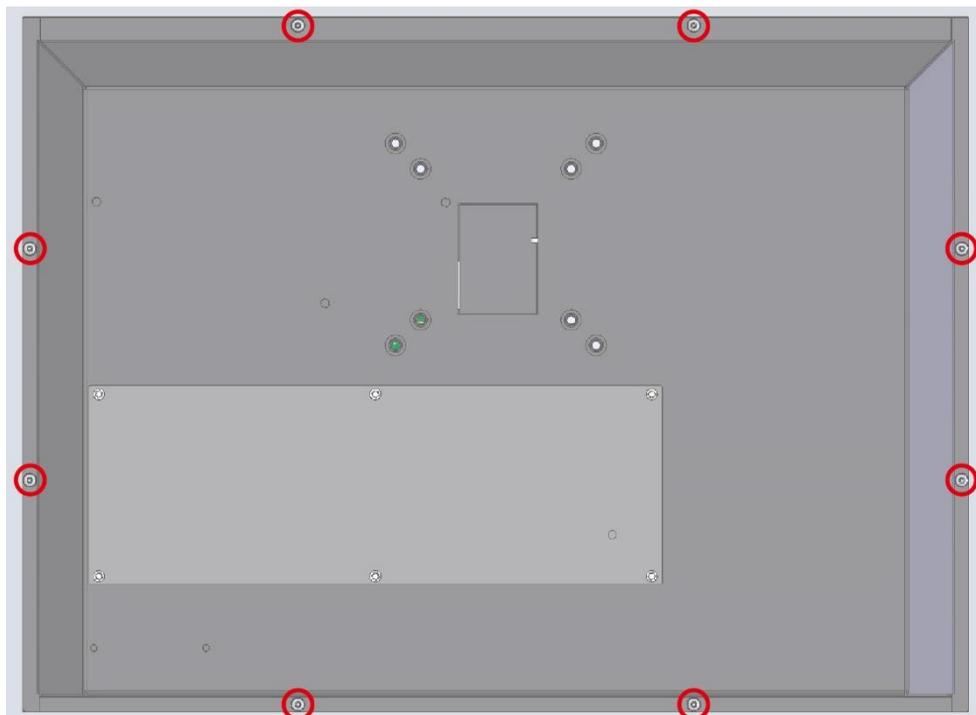
10.1 Disassembly

Loosen the 8 Torx screws using a TX10 Torx screw driver. If the display is changed while mounted on the carrier arm, the two upper Torx screws must be removed last and the display pulled straight forward.

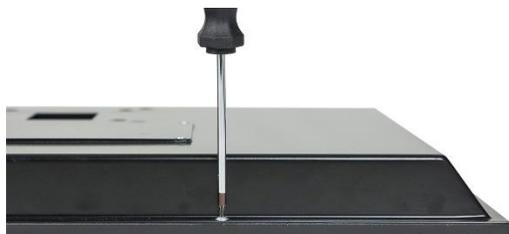
Next, carefully open the front.

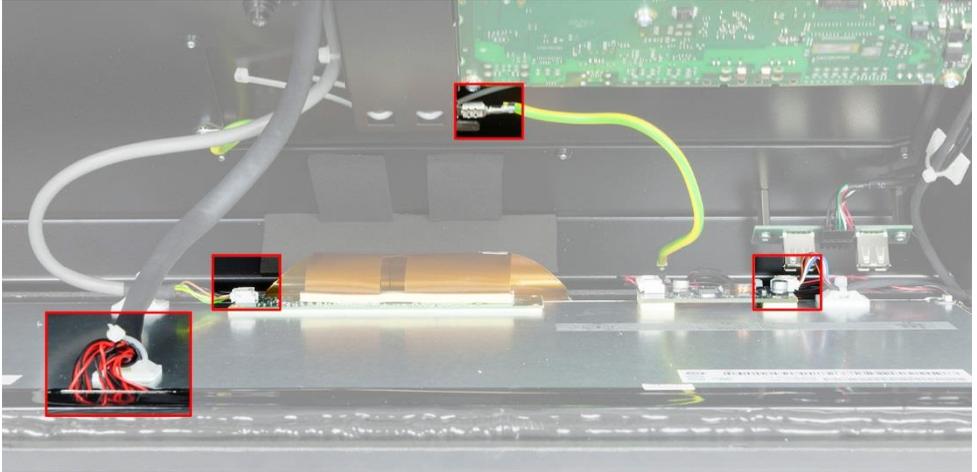
Photo shows view from the top.

First, all connectors indicated in the photo above must be disconnected.
For this purpose, the hot glue points on the connectors must be carefully removed and the cable ties cut from the nearest adhesive socket.

During each process, caution must be taken to ensure that the orange ribbon cable is not damaged, kinked or flattened. Otherwise disruptions or damage to the touch display can occur.
